Appendix B-5

Eastern Bypass Construction Debris Area Photographs

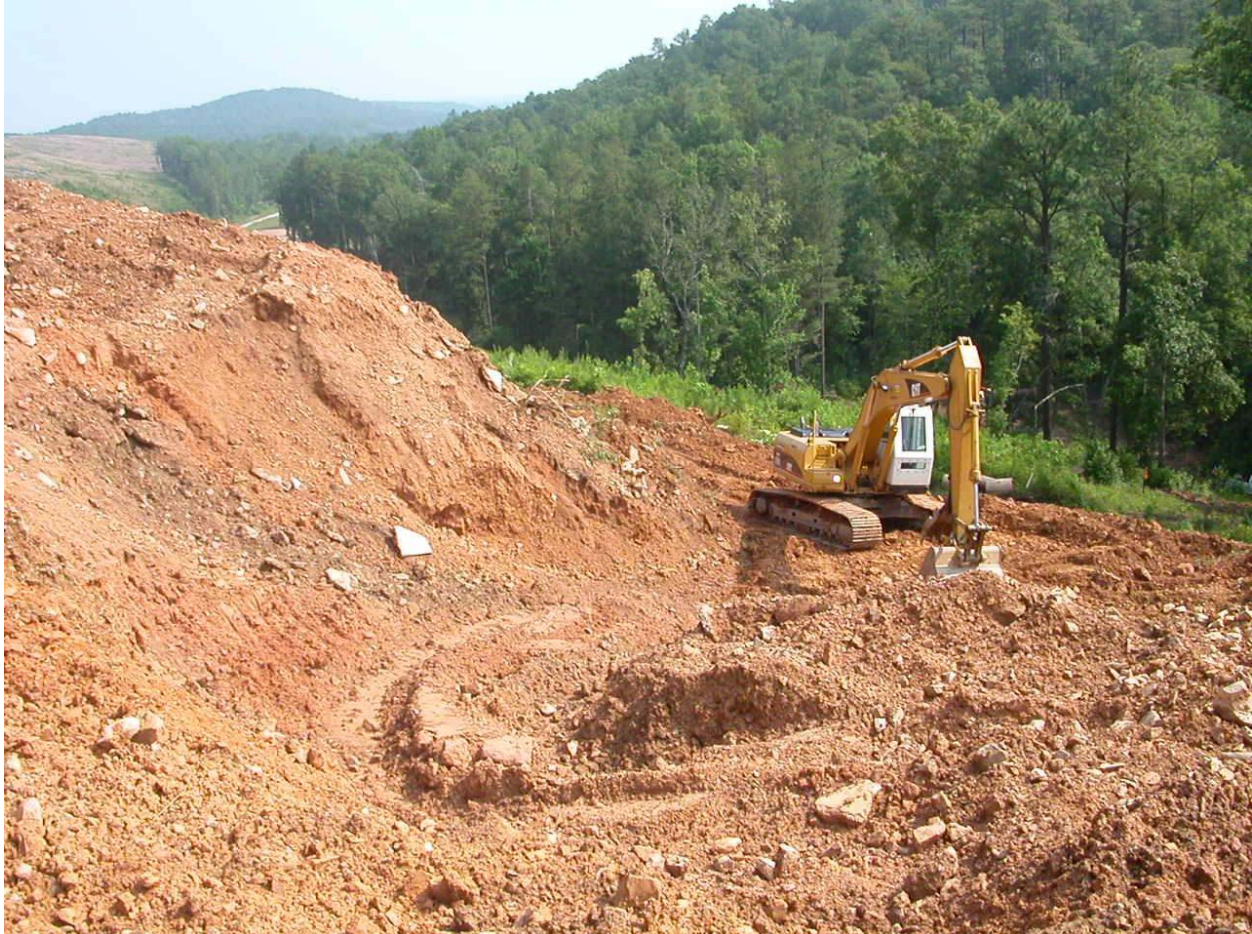
Digging operations in grids D22 and D23, South Area (SA).

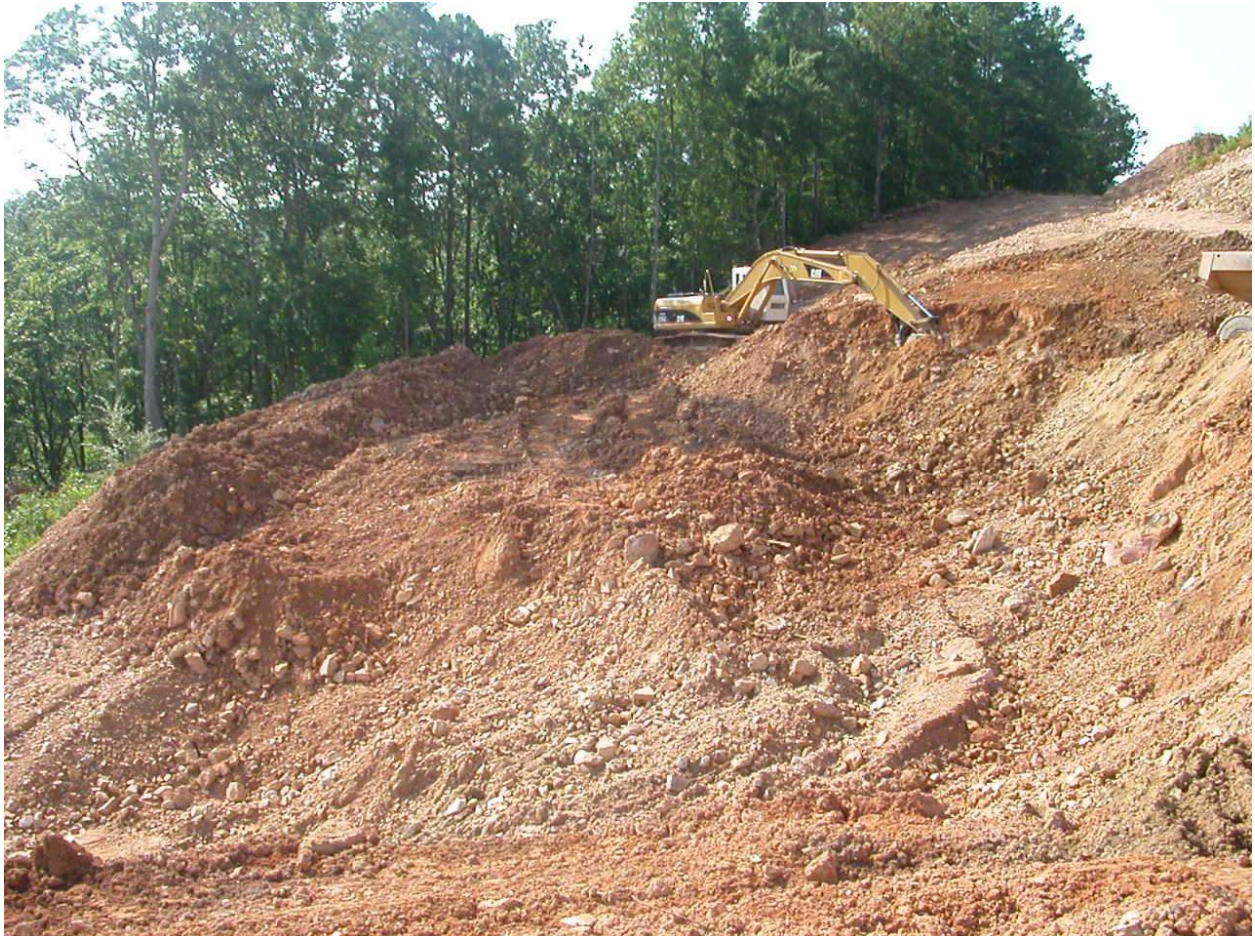
Digging operations in grid D23, South Area (SA).

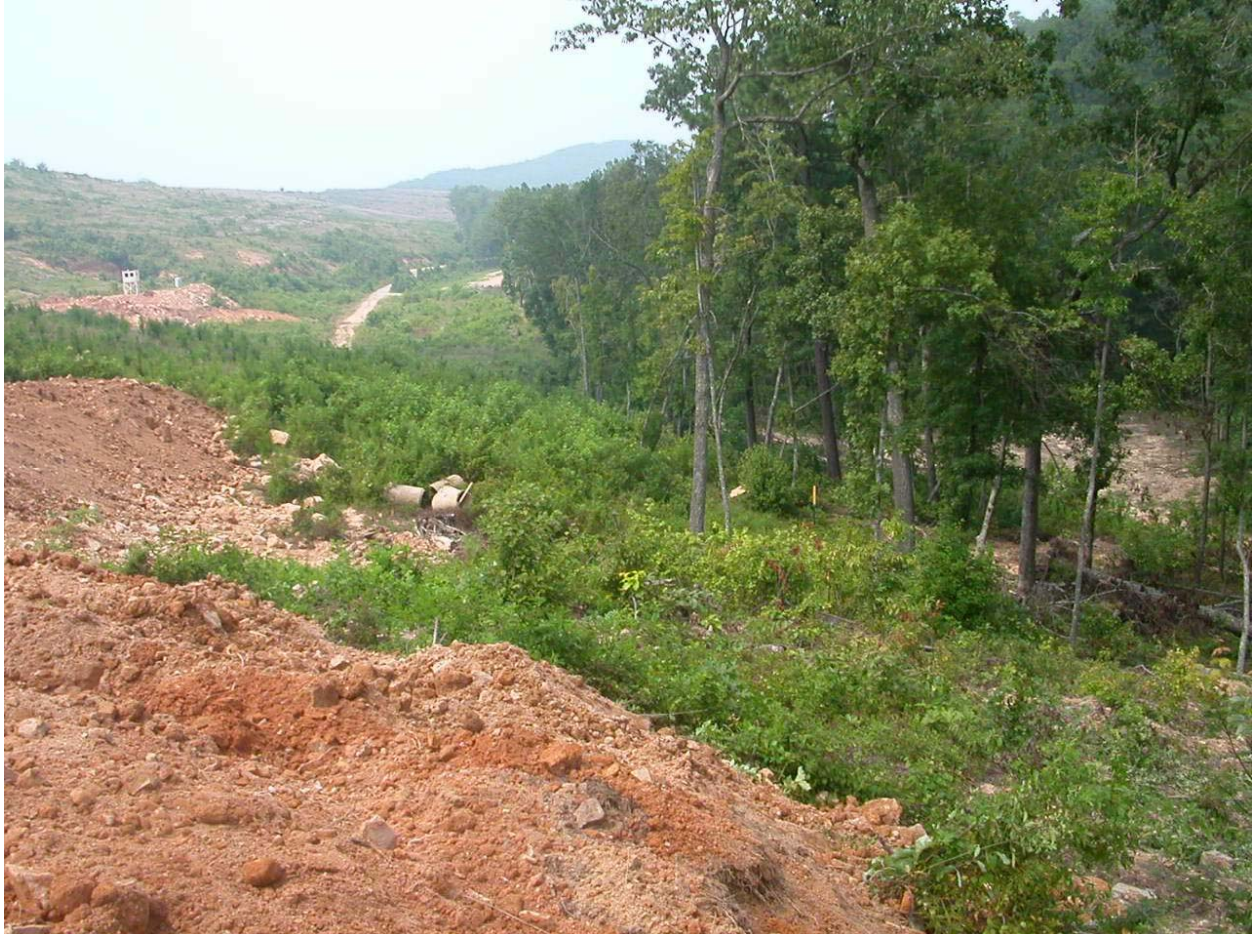
Eastern boundary of grid D23, South Area (SA).

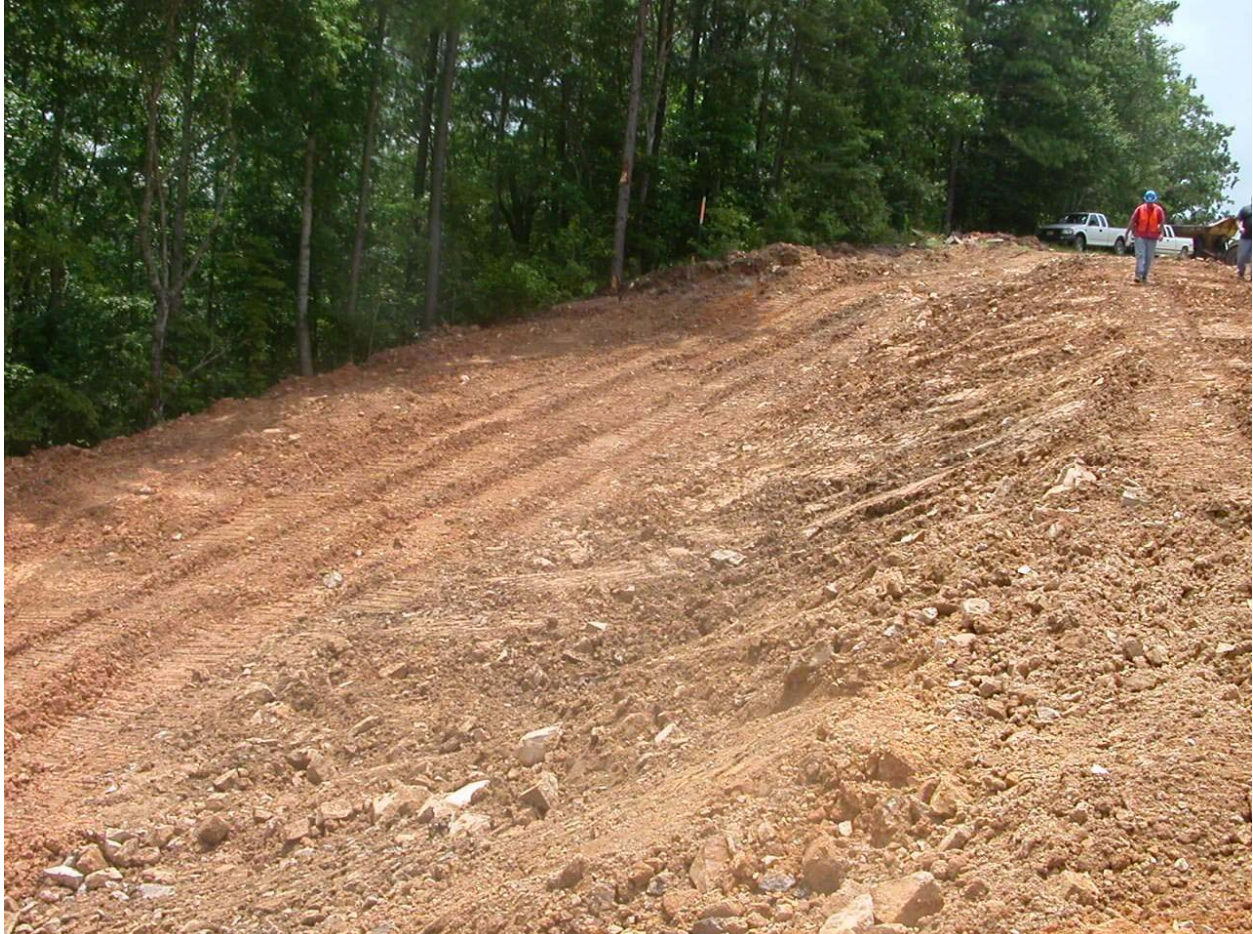
Northeastern side of grid D23, South Area (SA).

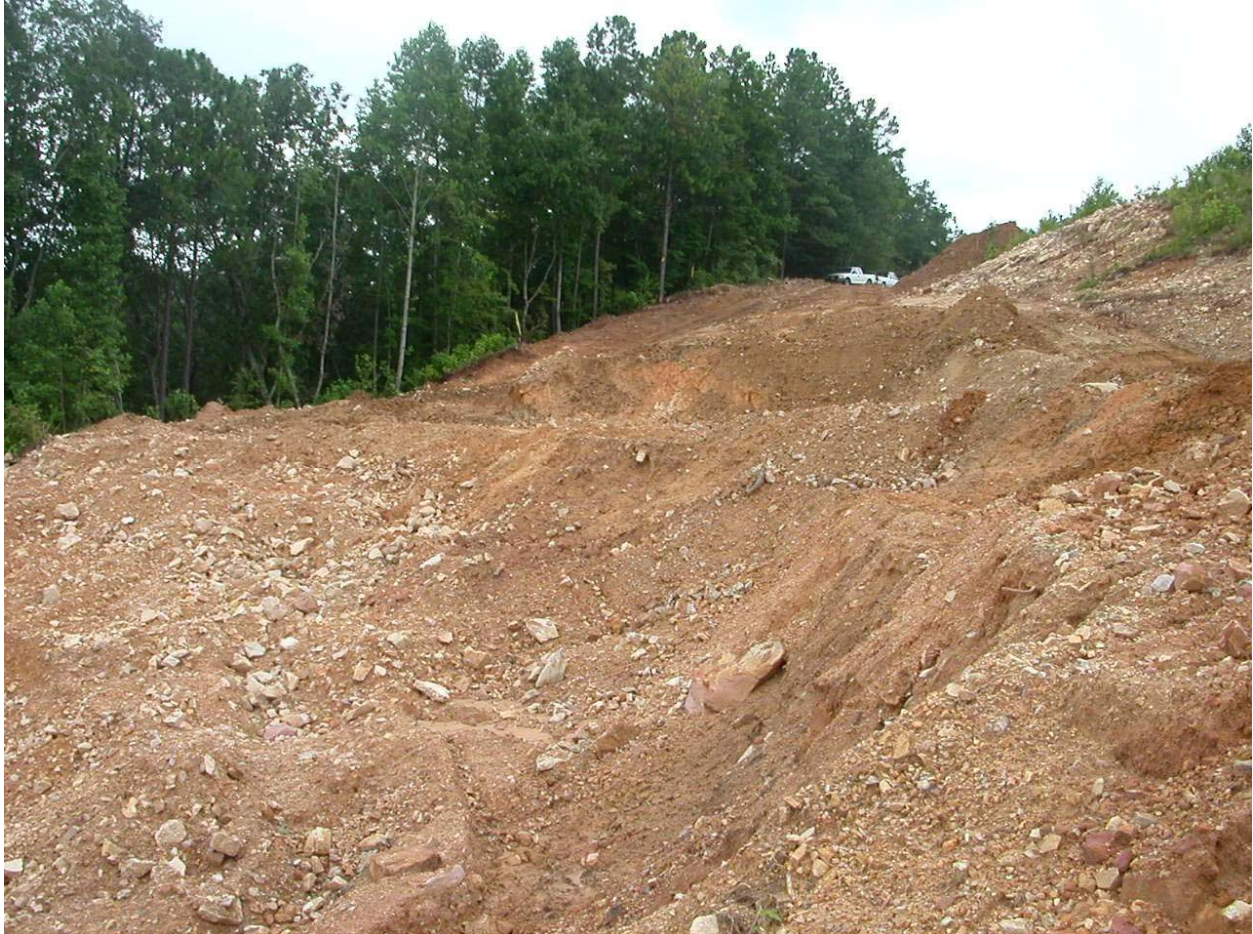
View of grids D22 and D23, South Area (SA).

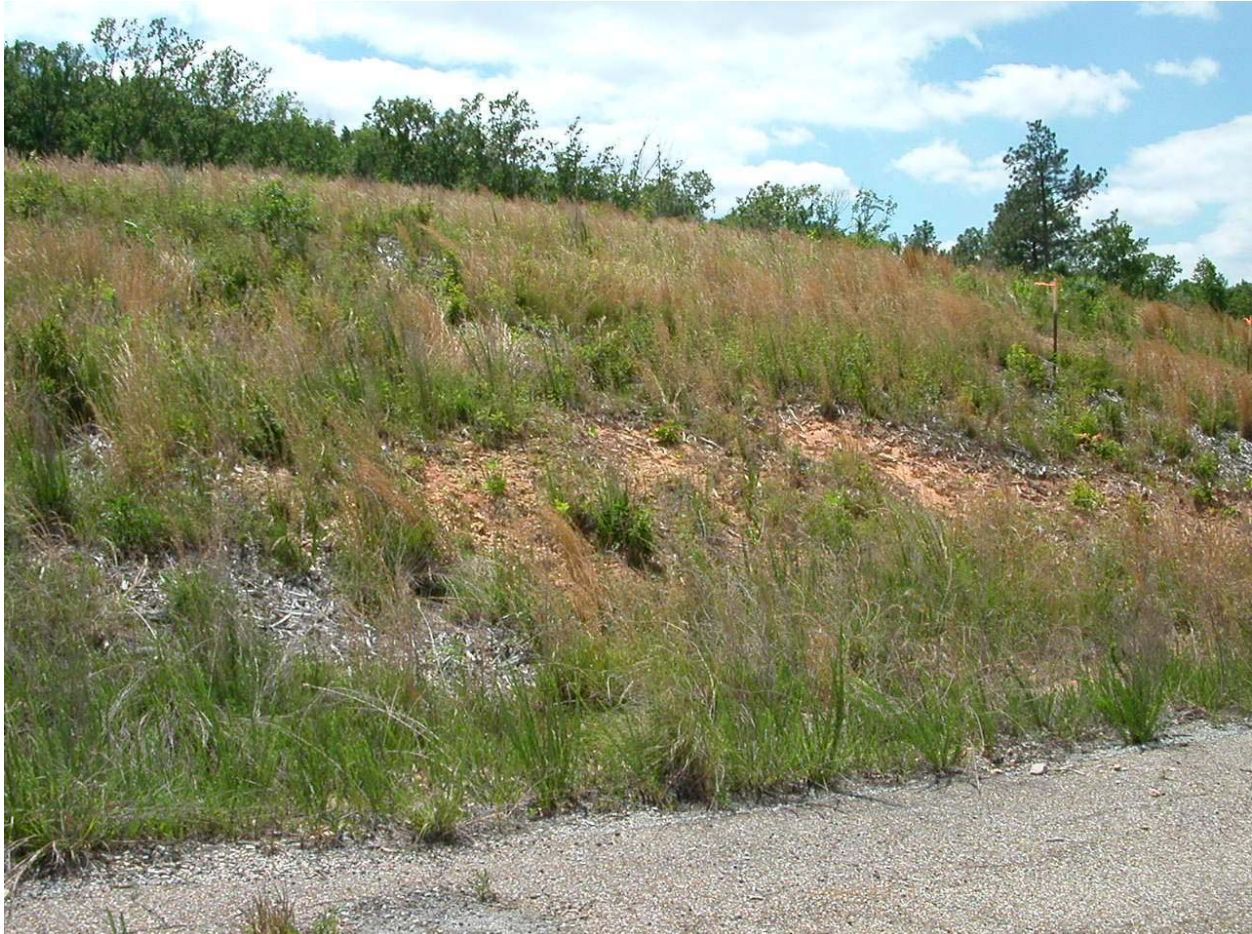
Grid D34 before removal.

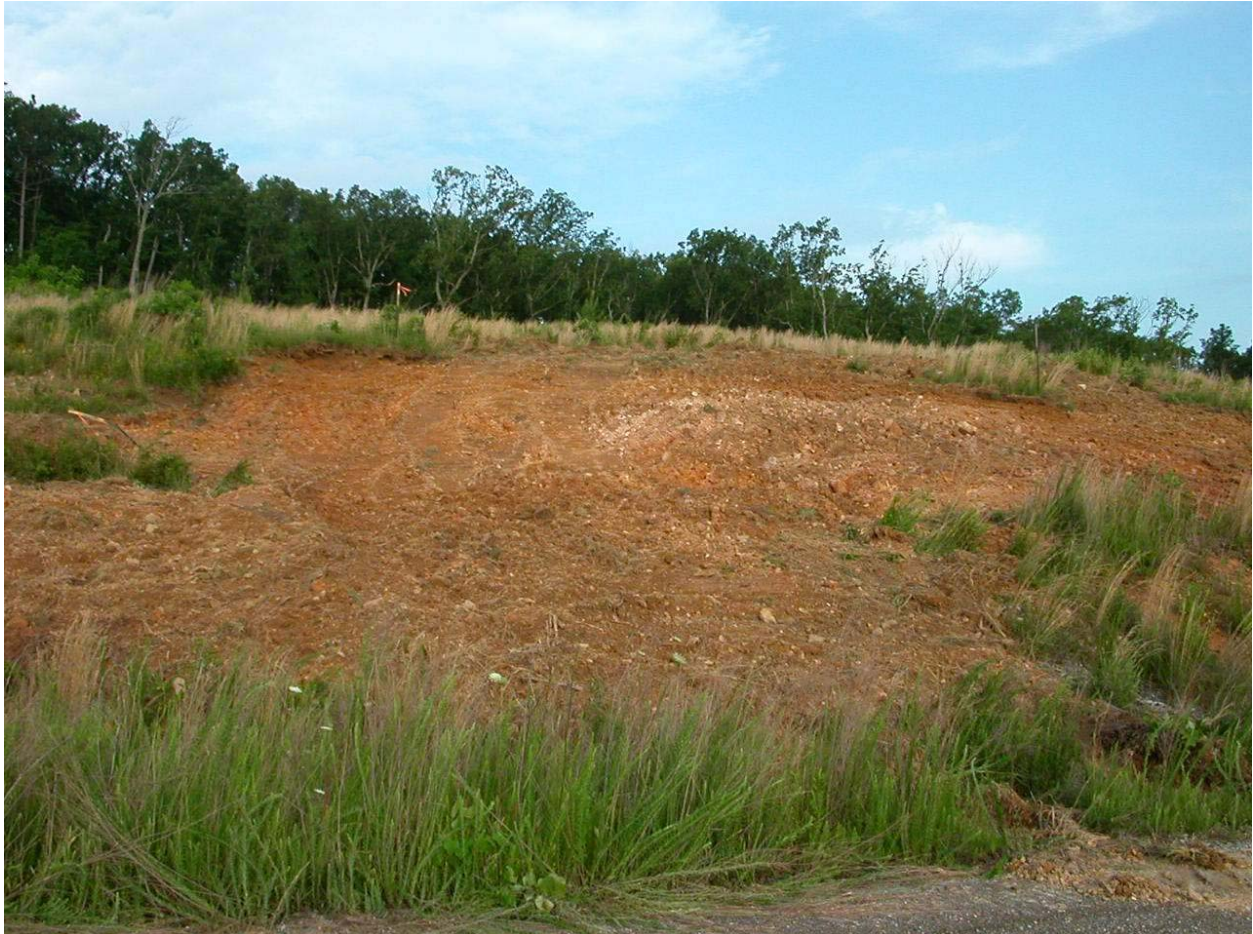
Grid D34 after removal.

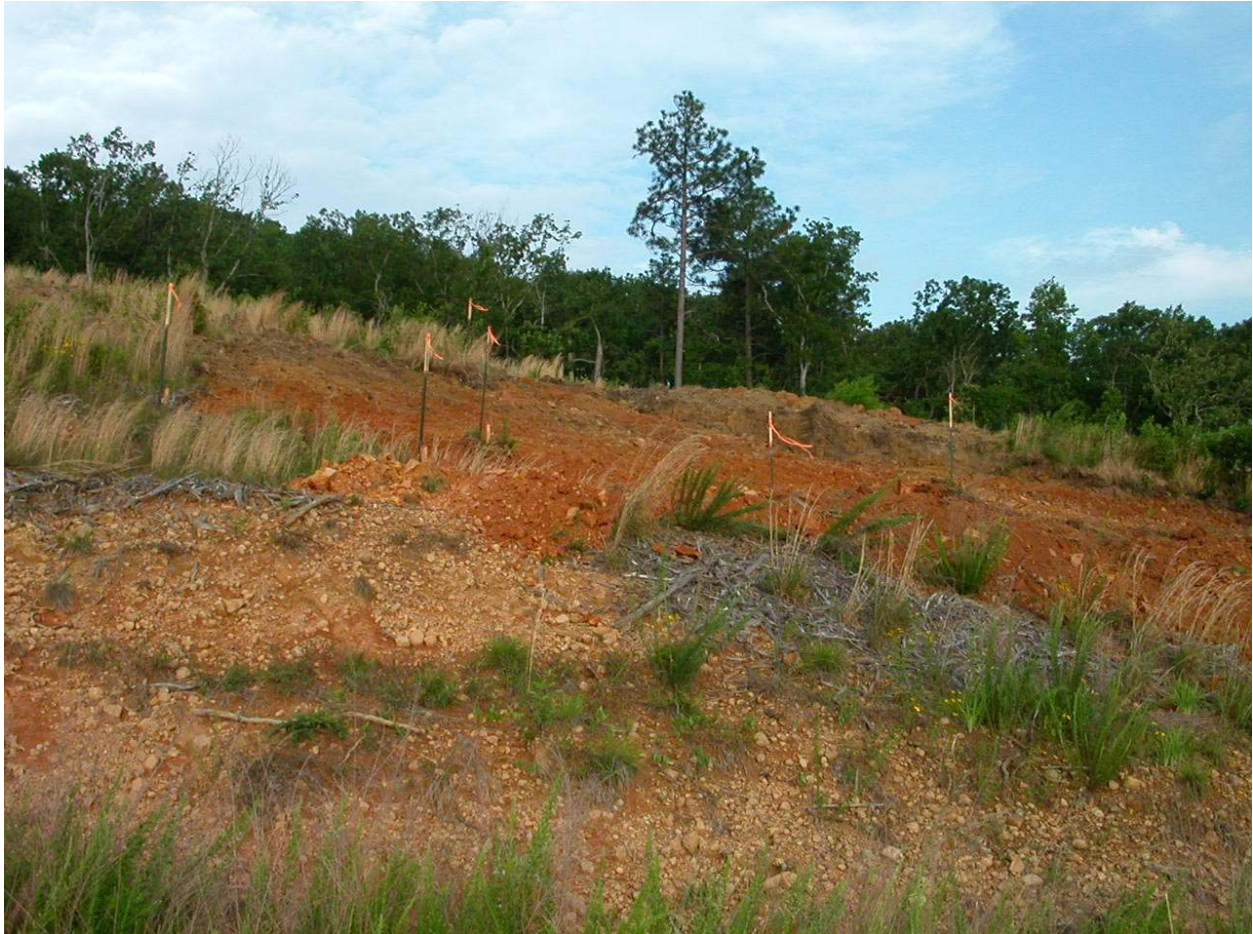
Grid D47 ready for mapping.

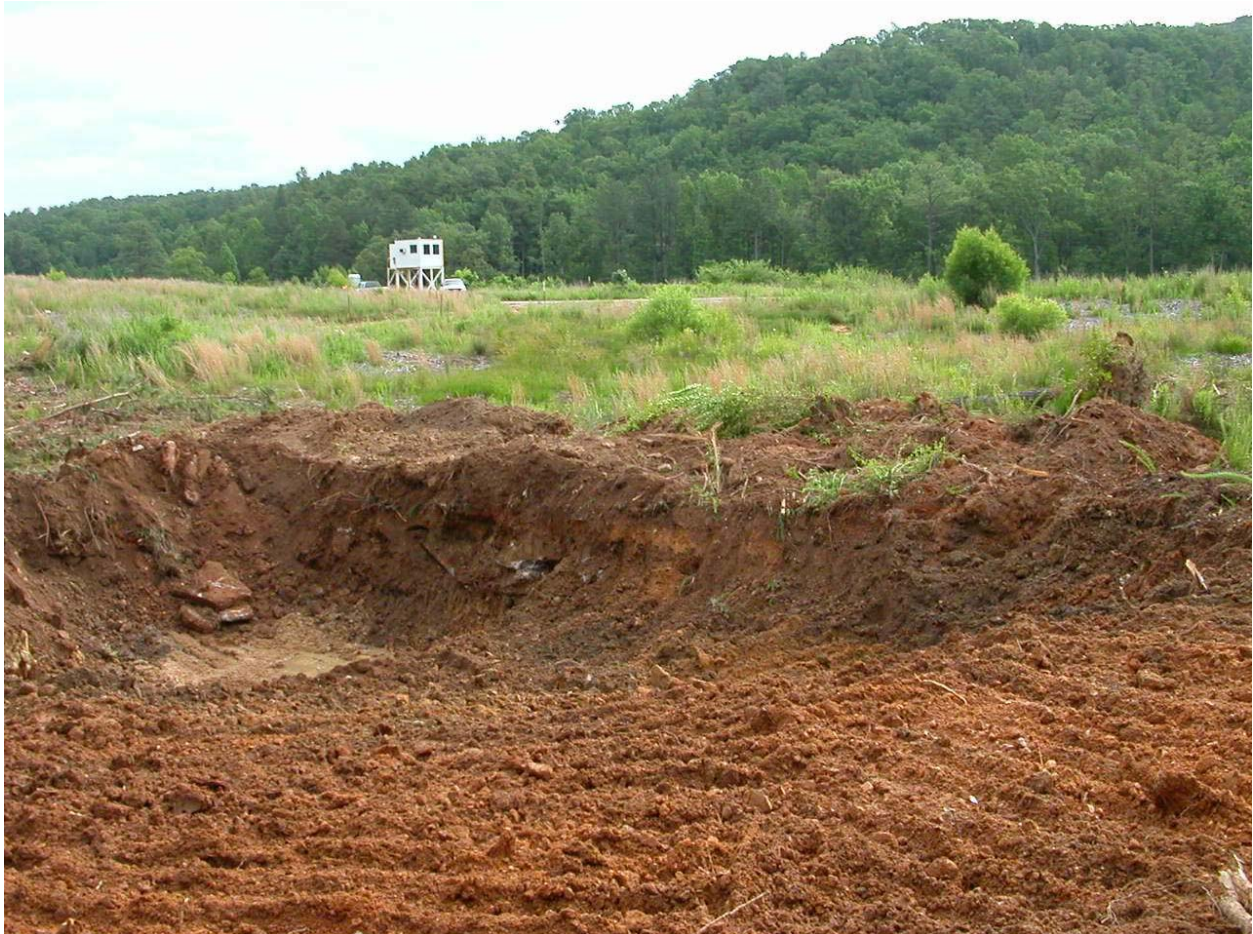
Digging in grid S04, Porta-Potty Road (PPR) area.

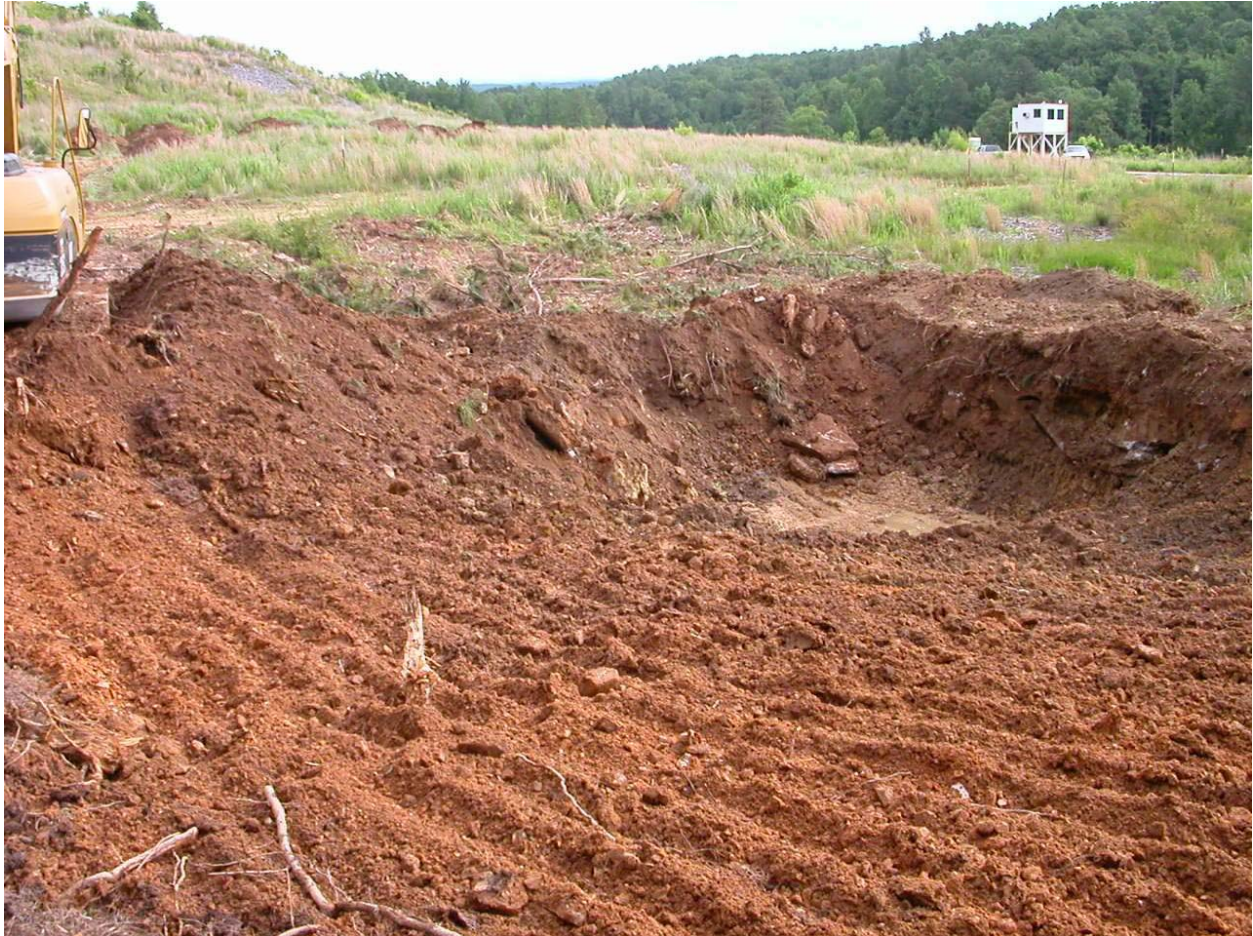
Grid S04, Porta-Potty Road (PPR) area.

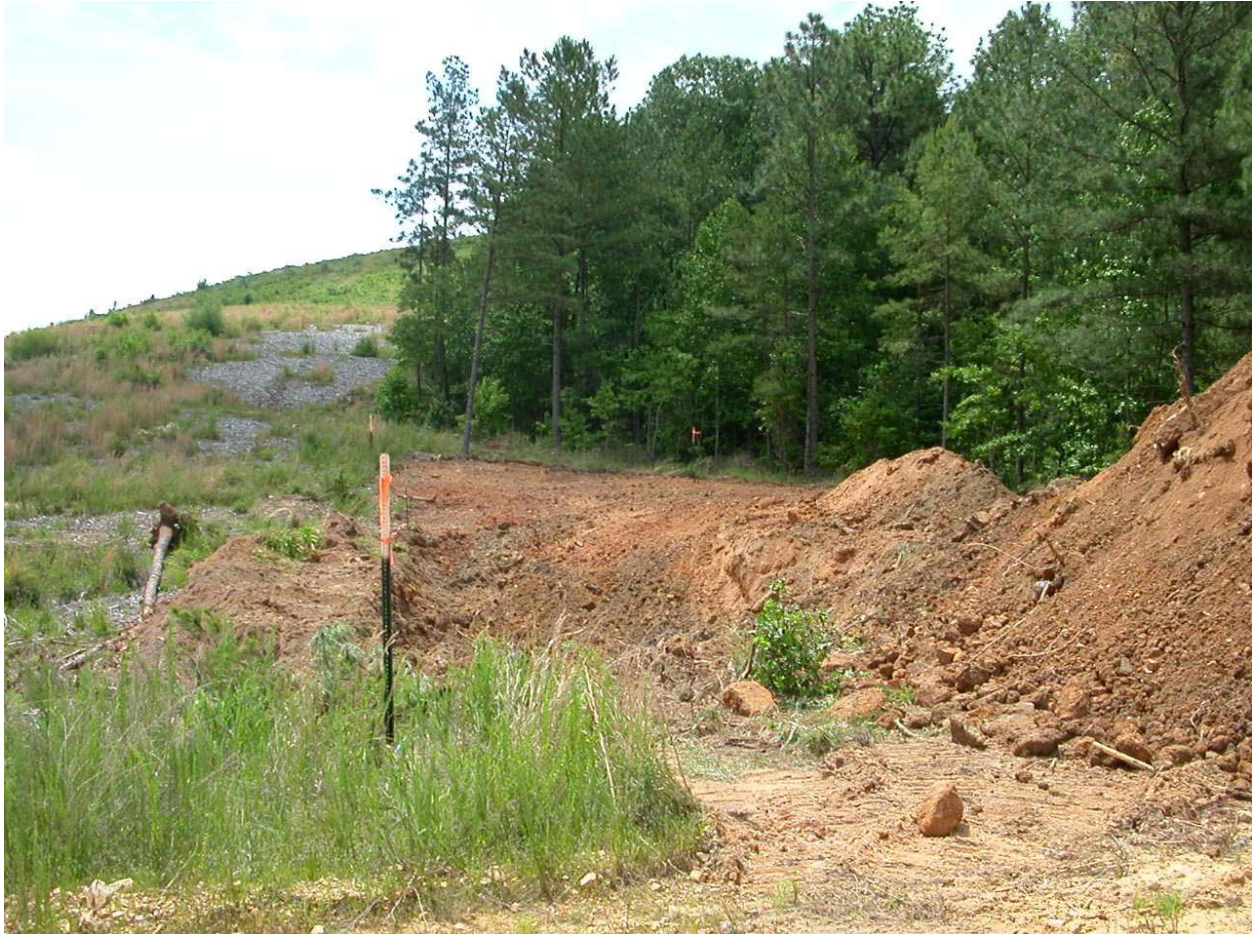
Grids S02, S03 and S04 ready for mapping, Porta-Potty Road (PPR) area.

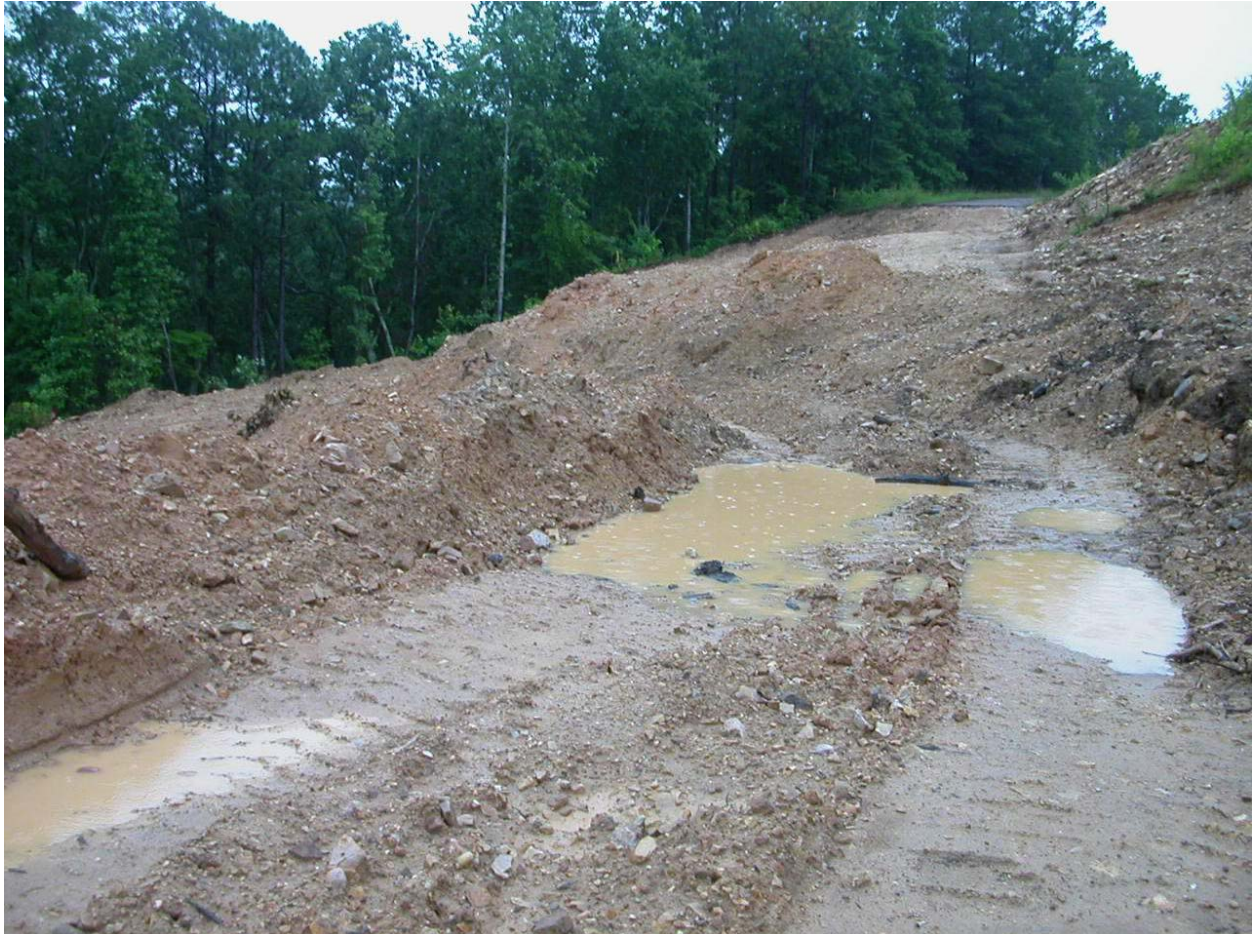
Heavy rain on July 6, 2005 that caused early stop of work.

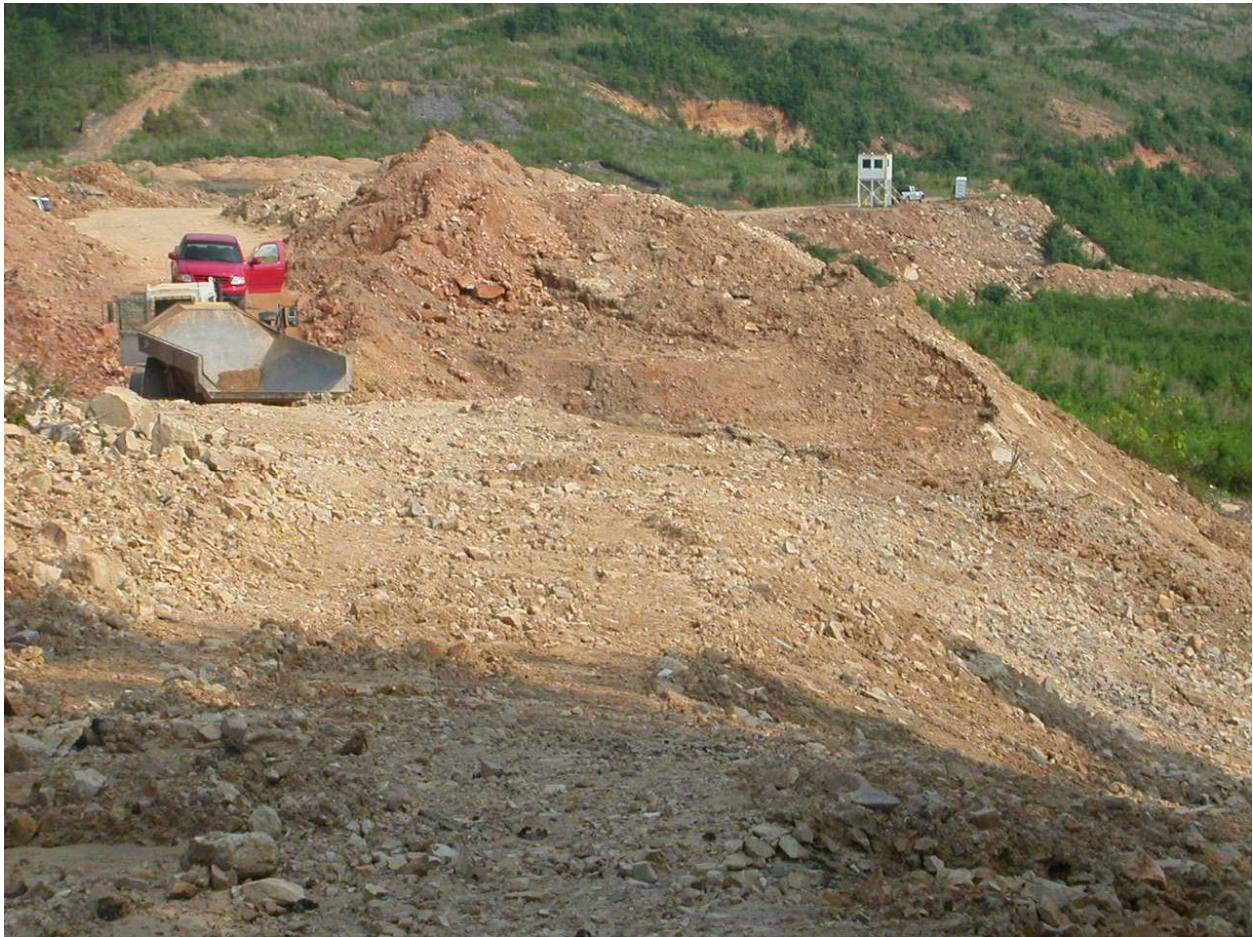
**Overview of the volume of construction debris encountered during the mechanical removal
in the Eastern Bypass area.**
